Sanitary Survey Report

**Polacca, Arizona
PWSID #0400106**

Survey Conducted on April 7, 2014

**Sanitary Survey
Polacca
PWSID #0400106
Survey Performed April 7, 2014**

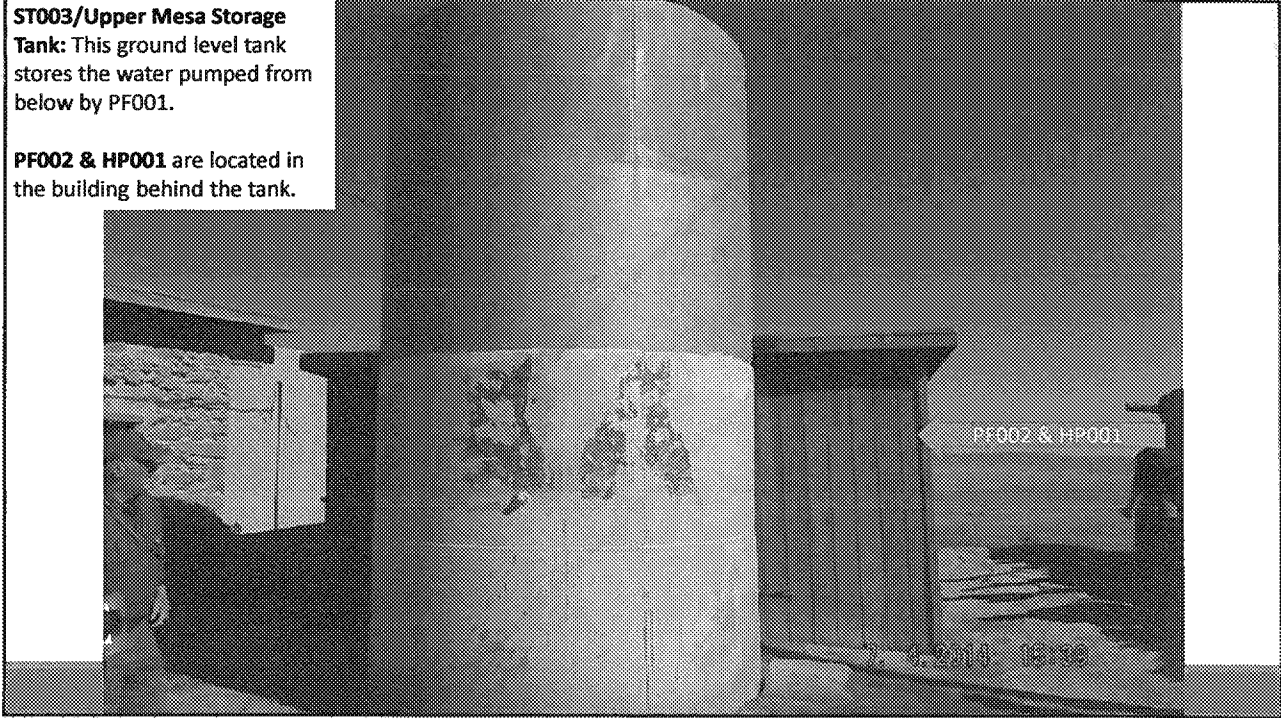
ST003/Upper Mesa Storage Tank: This ground level tank stores the water pumped from below by PF001.

PF002 & HP001 are located in the building behind the tank.

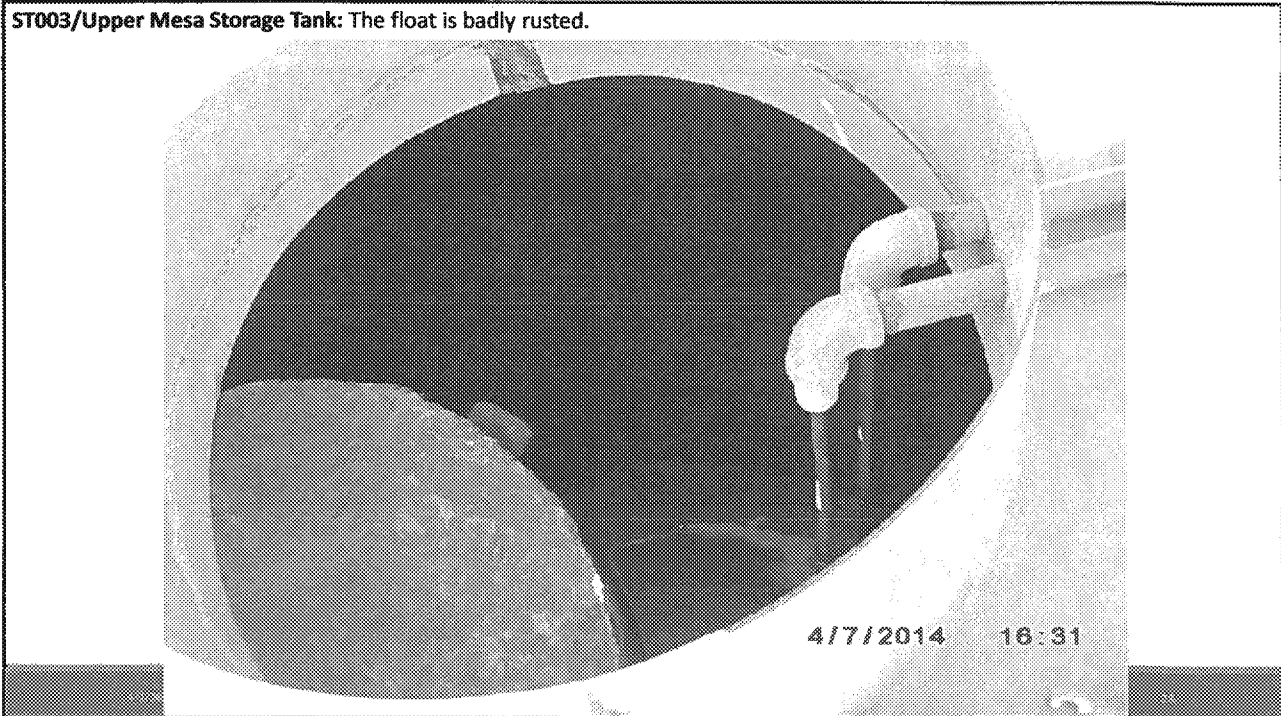
ST003/Upper Mesa Storage Tank: The float is badly rusted.

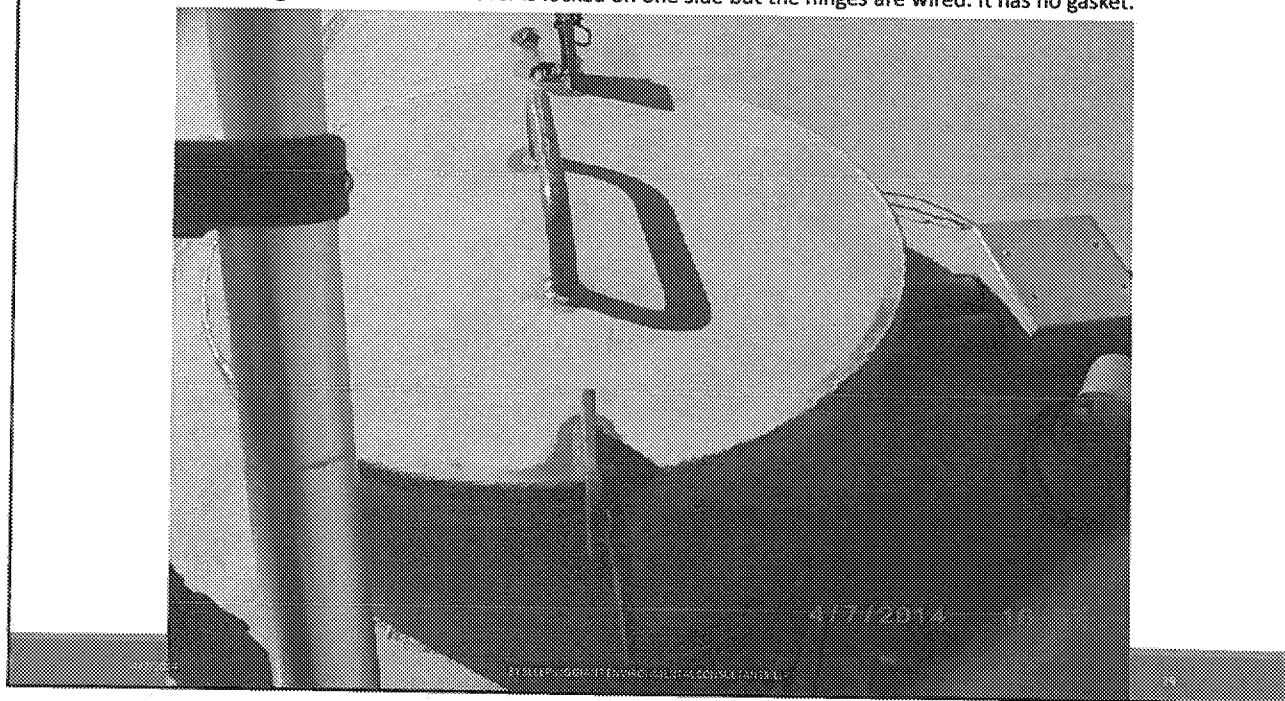
ST003/Upper Mesa Storage Tank: The hatch cover is locked on one side but the hinges are wired. It has no gasket.

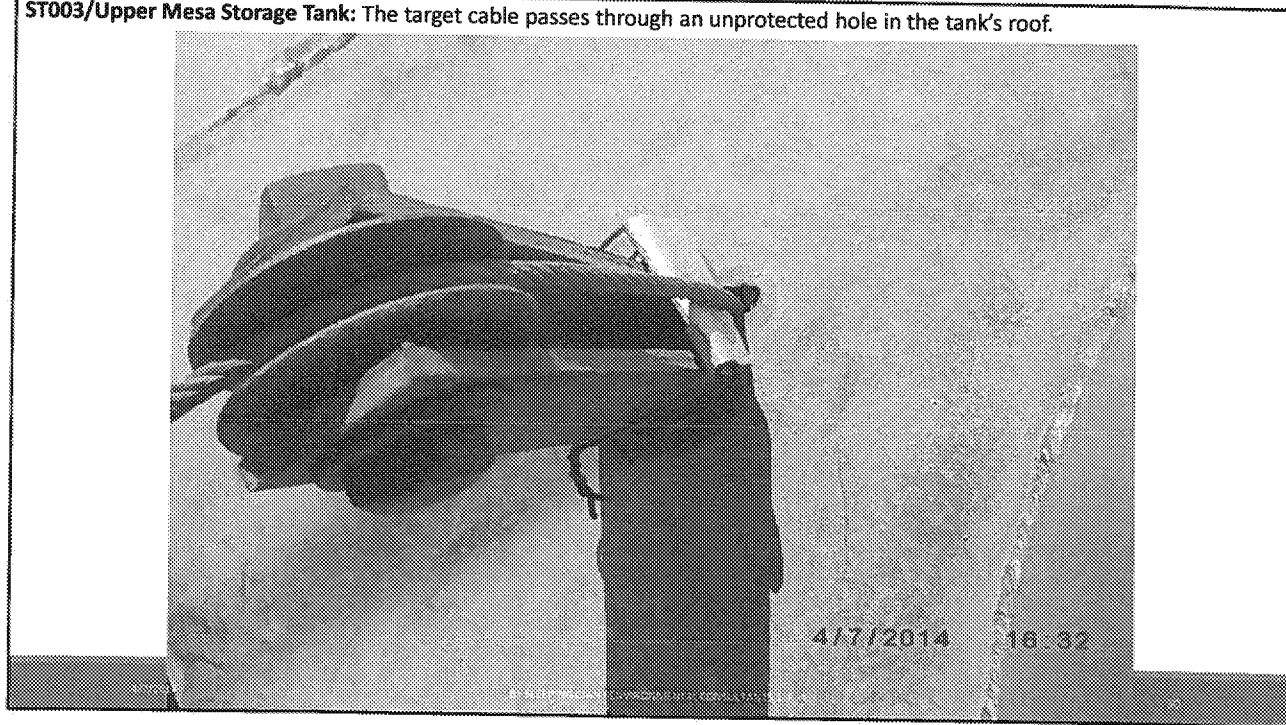
ST003/Upper Mesa Storage Tank: The target cable passes through an unprotected hole in the tank's roof.

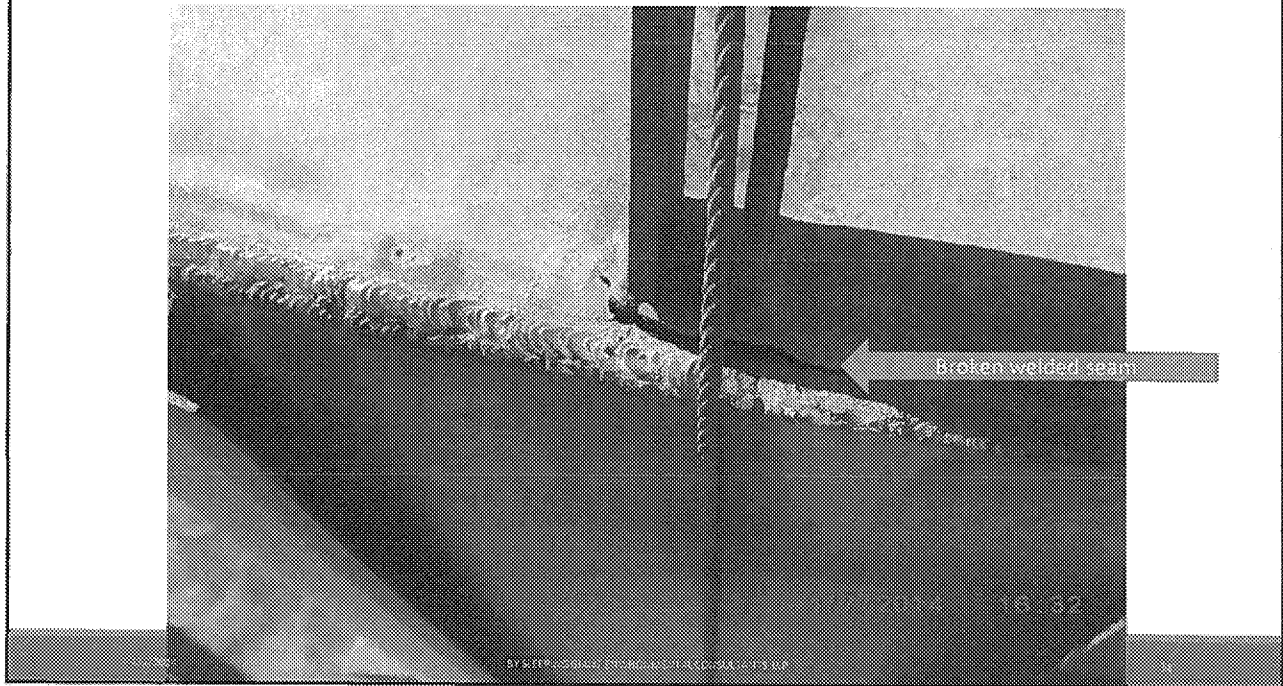
ST003/Upper Mesa Storage Tank: This is an opening caused by corrosion.

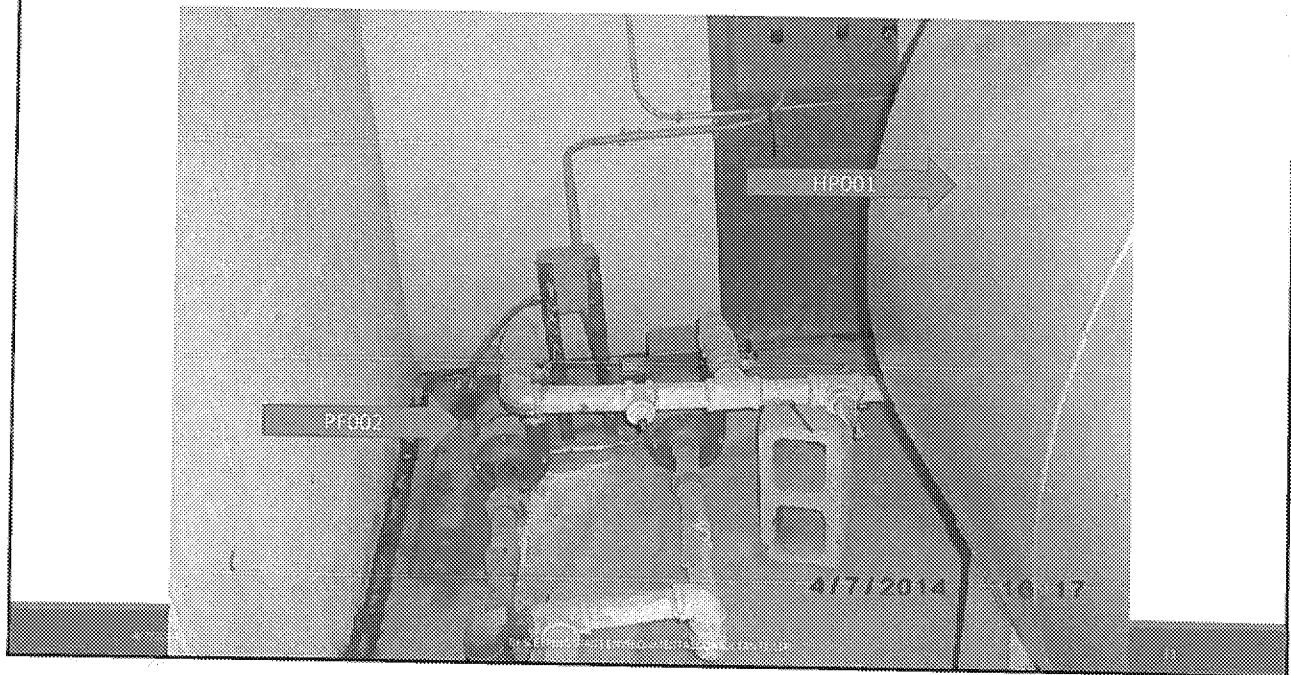
PF002/Upper Mesa Booster Pumping Facility & HP001/Hydropneumatic Tank 1: The duplex pumping facility operates off a pressure switch.

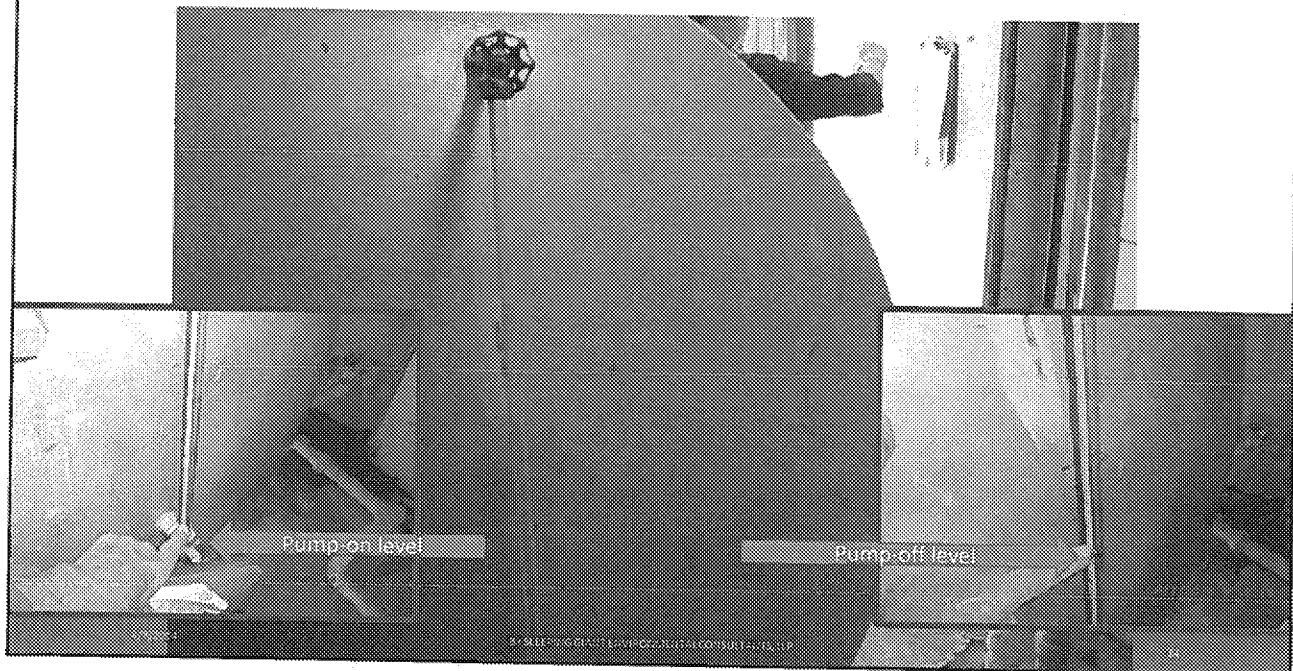
PF002/Upper Mesa Booster Pumping Facility & HP001/Hydropneumatic Tank 1: The air/water interface hydropneumatic tank has a sight gauge.

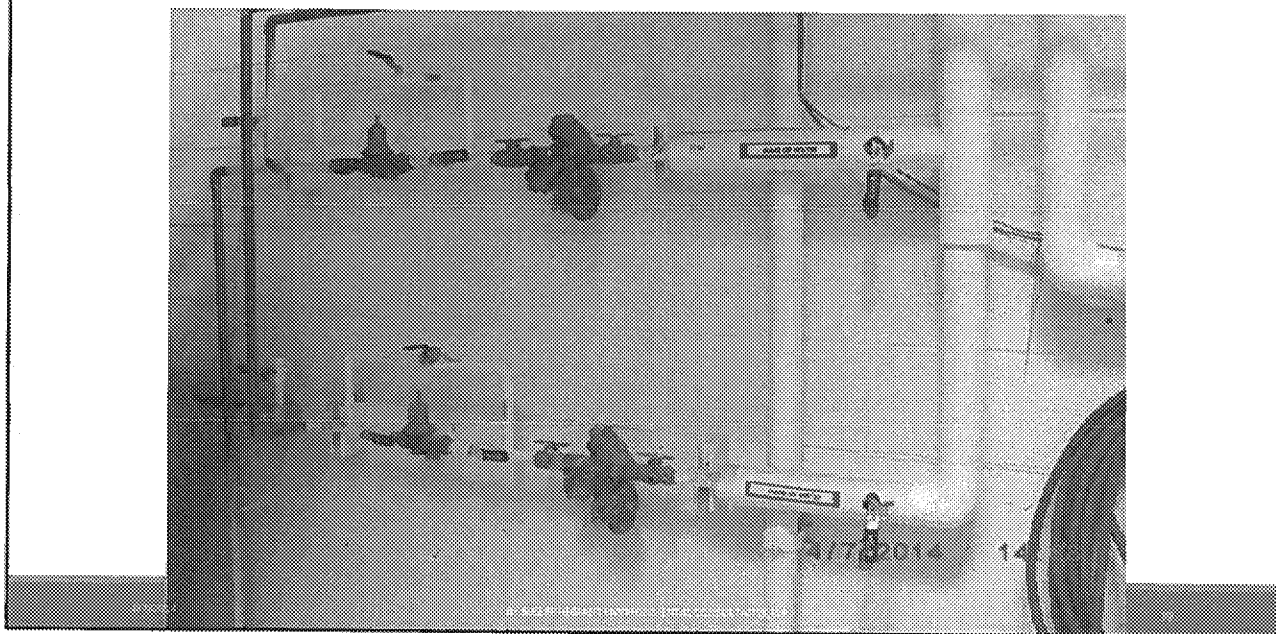
Backflow Preventers on boiler makeup water lines. The owners of the facilities that have backflow preventers are responsible for having them tested annually and keeping them in good working order. It is the responsibility of the PWS to make sure this is done.

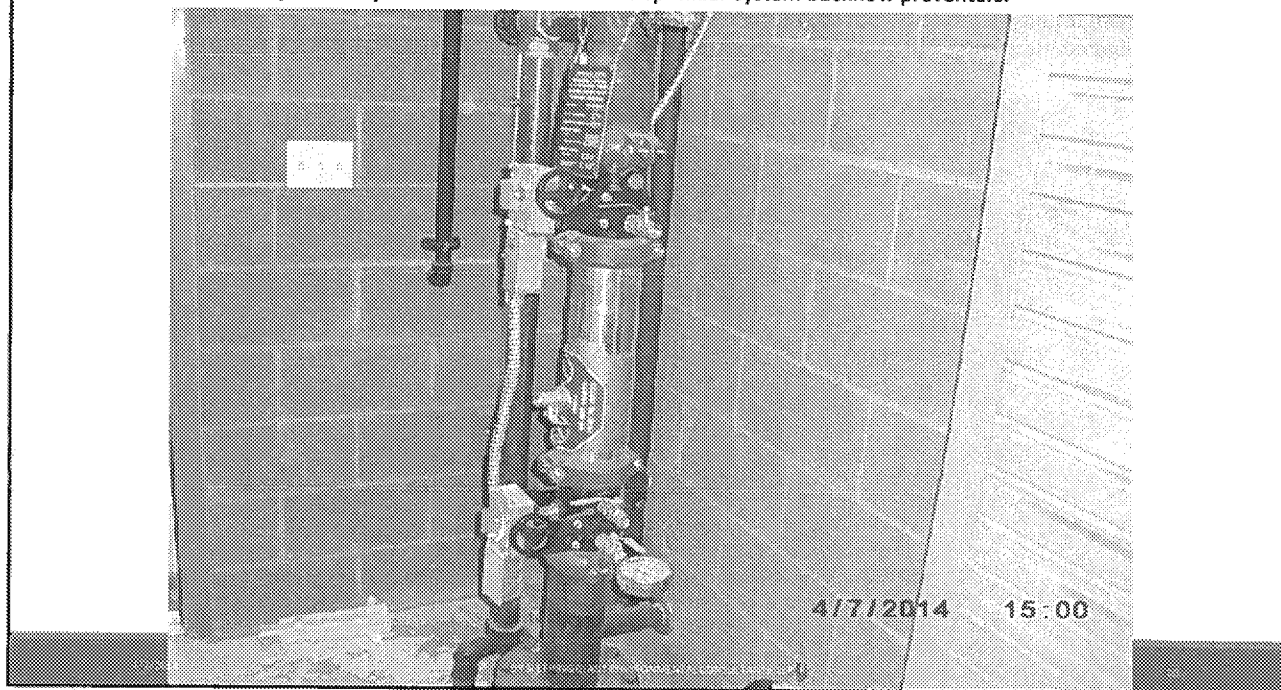
Backflow Preventers fire sprinkler system. One of the IHS's fire sprinkler system backflow preventers.
